Report No. D180-18752-3

FINAL REPORT

Development of Hybrid Thermoplastic Composites

RESEARCH AND ENGINEERING DIVISION
BOEING AEROSPACE COMPANY
SEATTLE, WASHINGTON 98124

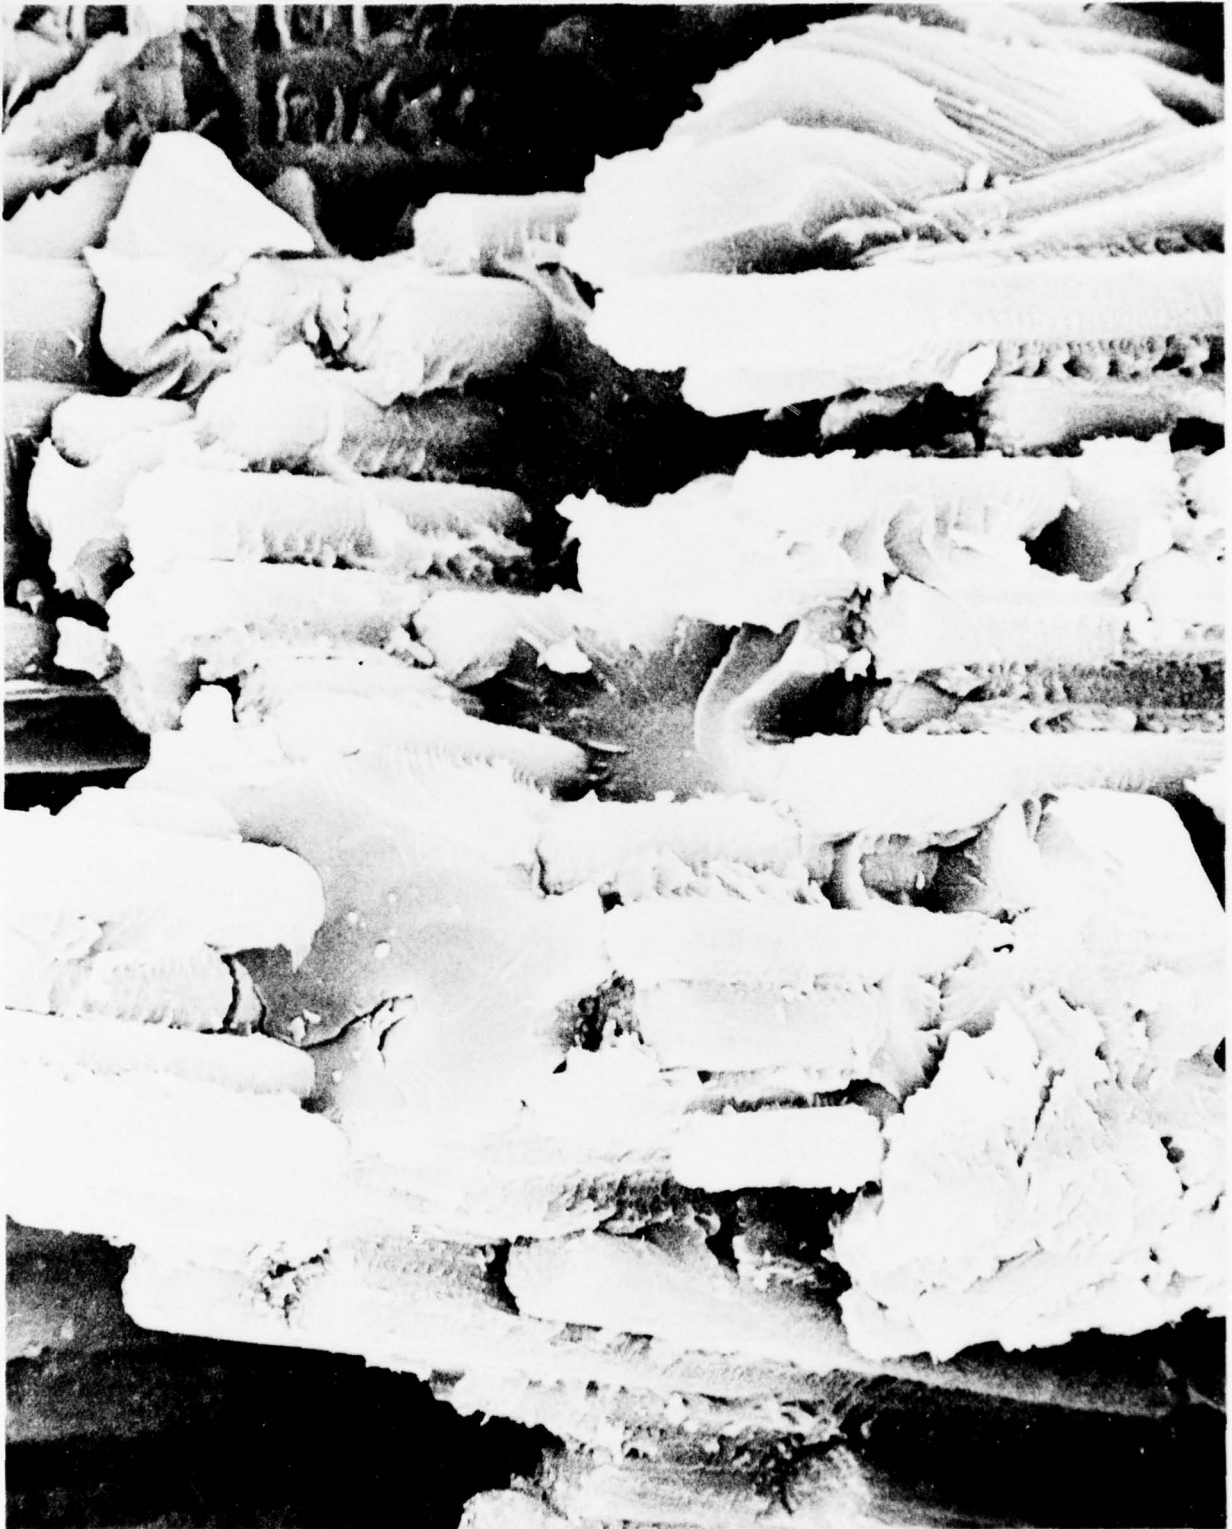
Figure 1: PKXA .24/A-S-Epoxy Unidirectional Graphite Composite (600X)

Scanning electron photomicrographs were taken of a failed flexural specimen from each of the resin systems at a 45° angle to the fracture. Figures 1 and 2 are the scanning electron photomicrographs of the failed PKXA and P-1700 specimens, respectively.

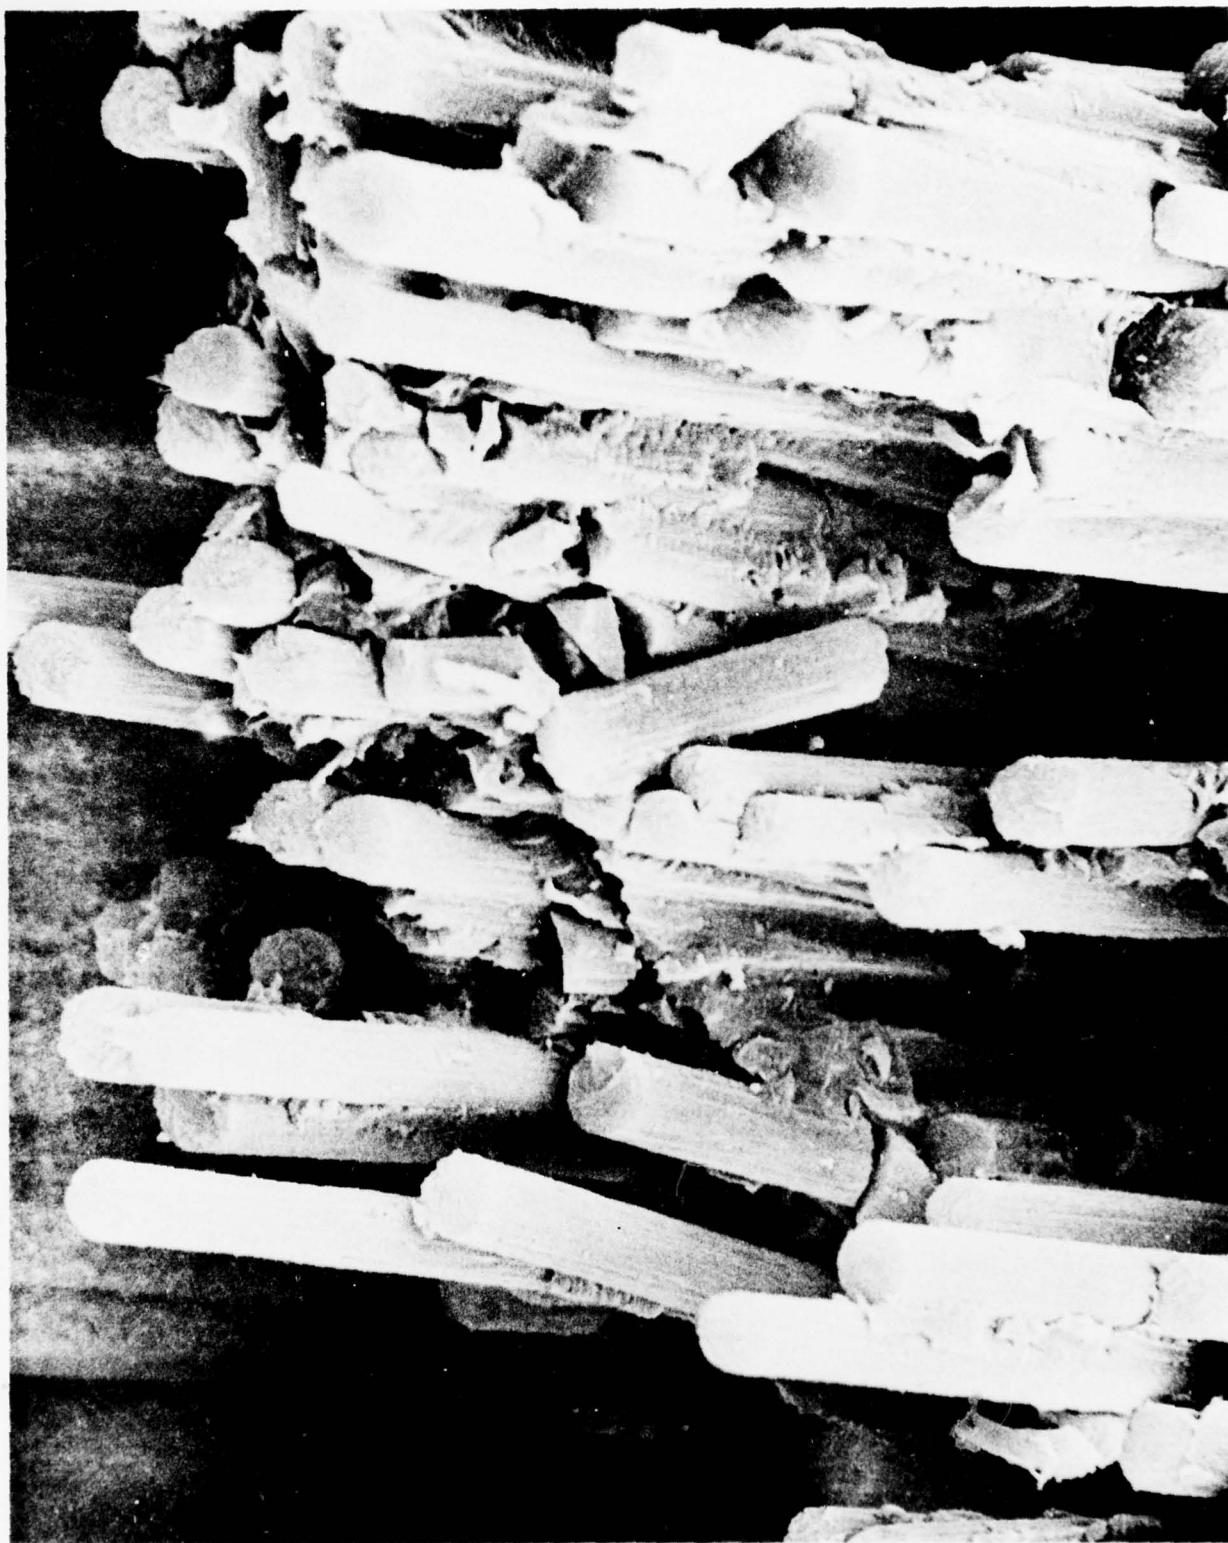
Figure 2: P-1700/A-S-Epoxy Unidirectional Graphite Composite (600X)

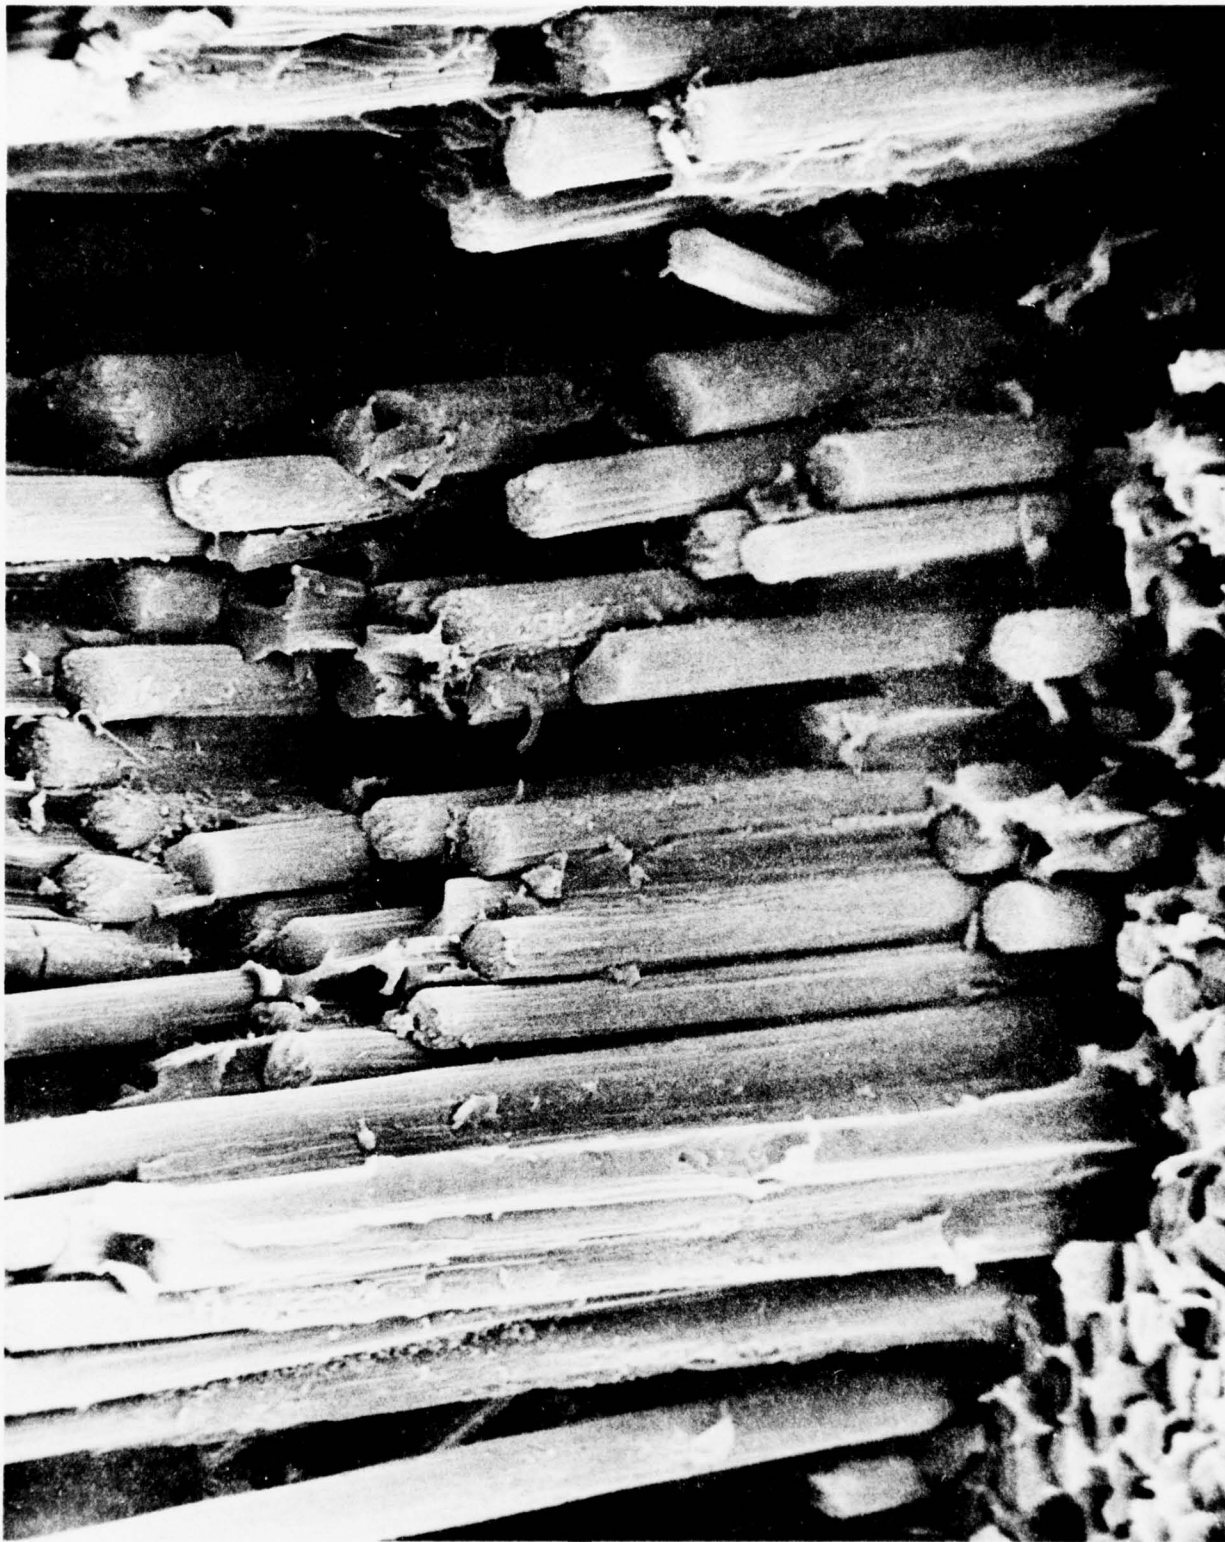
Figure 3: PKXA .24/HM-S Unidirectional Graphite Composite (600X)

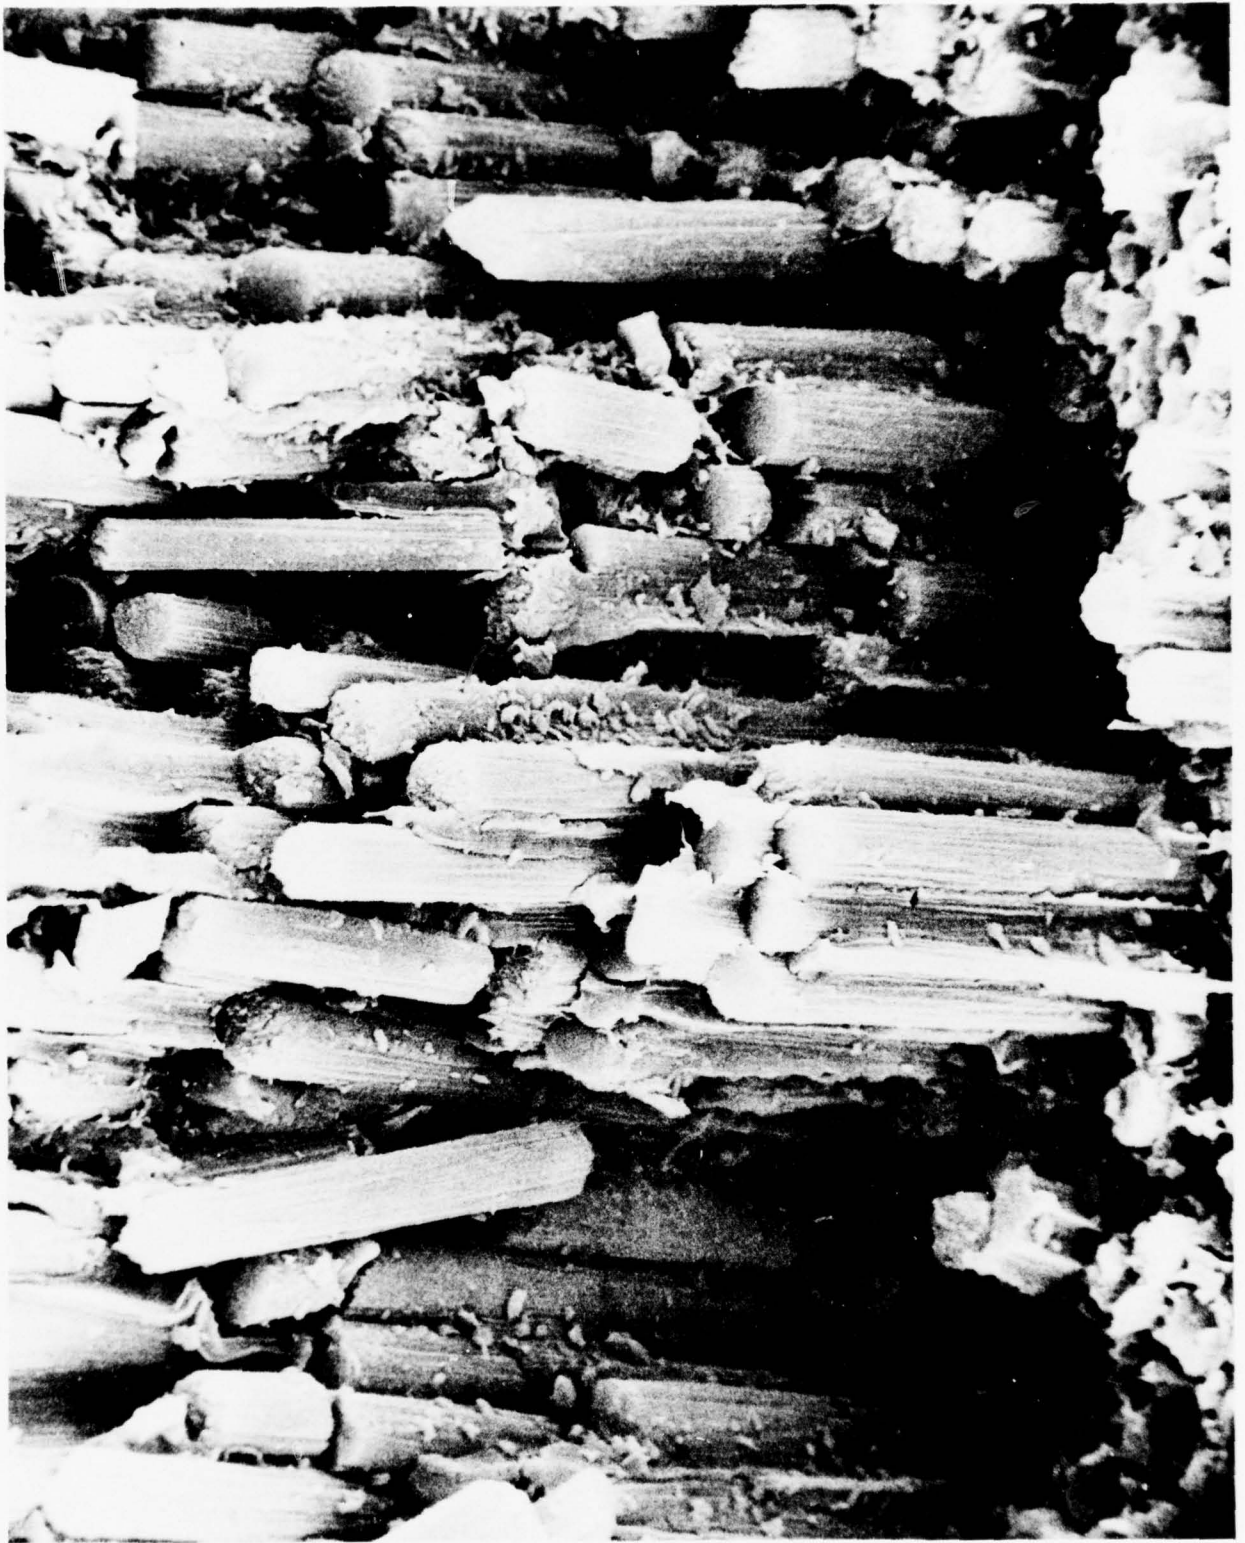
Figure 4: PKXA .41/HM-S Unidirectional Graphite Composite (600X)

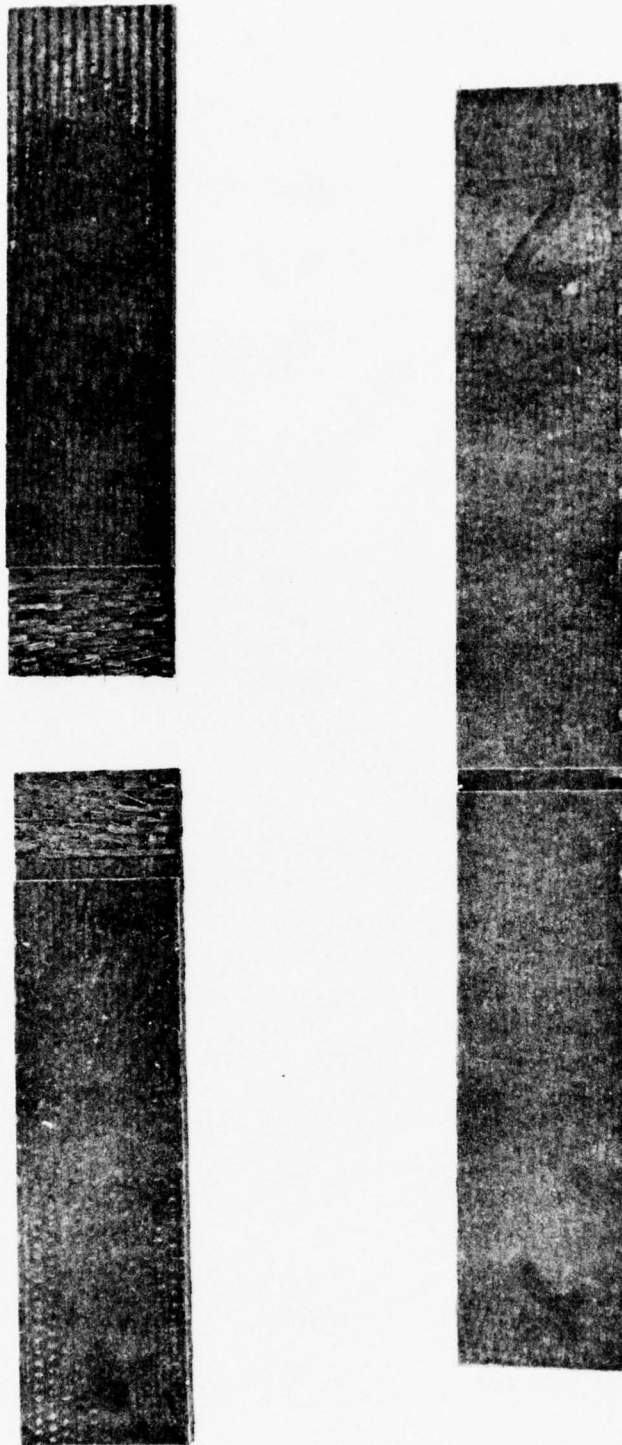
P-1700/GRAPHITE/S-GLASS FABRIC

Figure 24: Interlaminar Shear Specimens – Typical Fracture

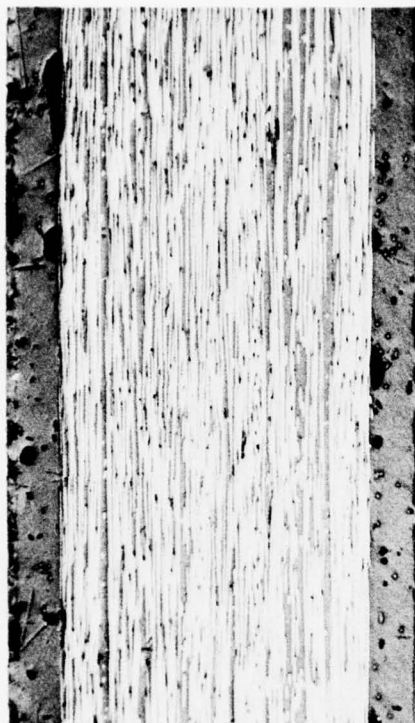
*Figure 34: Aluminum Clad Laminate
Before Thermal Shock (50X)*

Metal-clad laminates were exposed to 200 cycles of thermal shock (-65°F to +250°F) and thermal aging (500 hours at 250°F), to determine if differences in thermal expansion of the materials would cause delamination. The tests appeared to have no adverse effect on the composites. Figures 34 through 41 are photographs of the laminates before and after exposure.

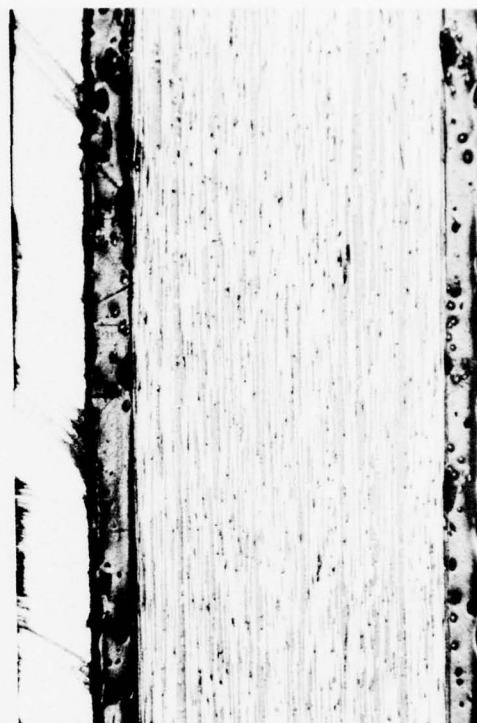
*Figure 35: Aluminum Clad Laminate
After Thermal Shock (50X)*

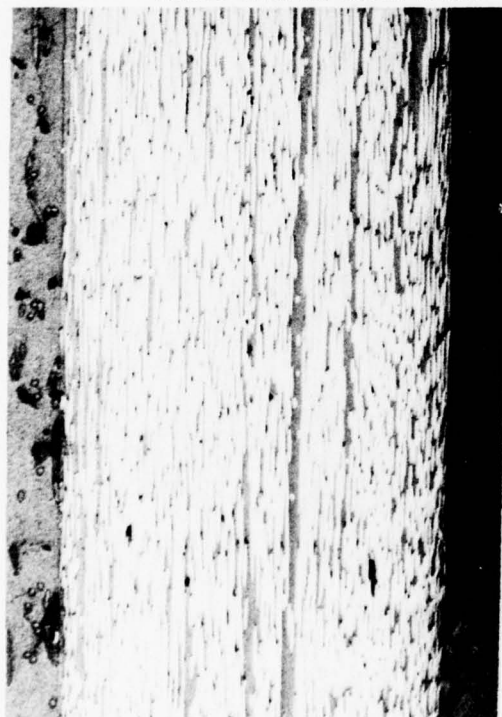
*Figure 36: Aluminum Clad Laminate
Before Heat Aging (50X)*

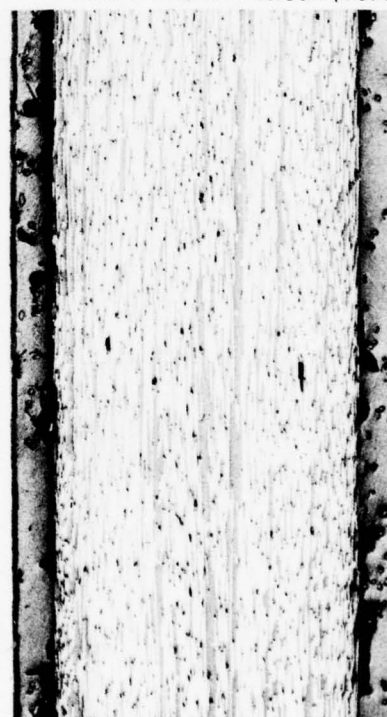
*Figure 37: Aluminum Clad Laminate
After Heat Aging (50X)*

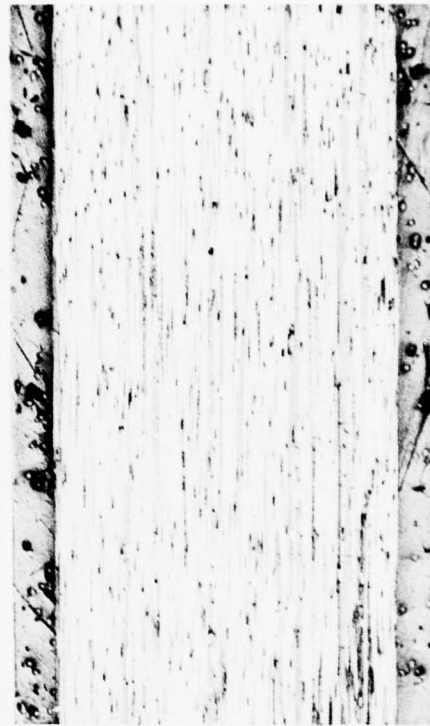
Figure 39: Steel Clad Laminate
After Heat Aging (50X)

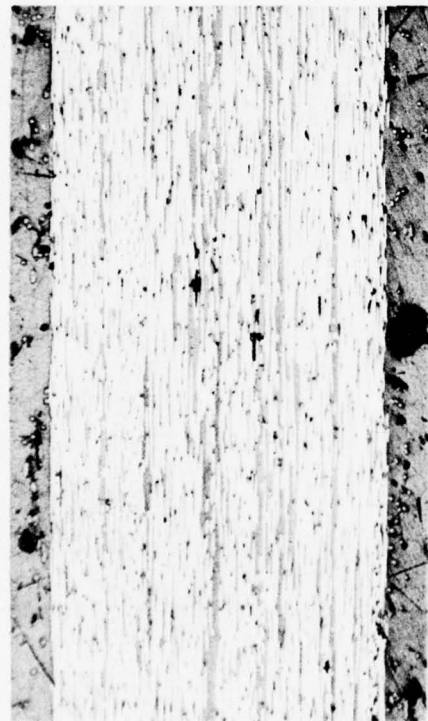
Figure 40: Steel Clad Laminate
Before Thermal Shock (50X)

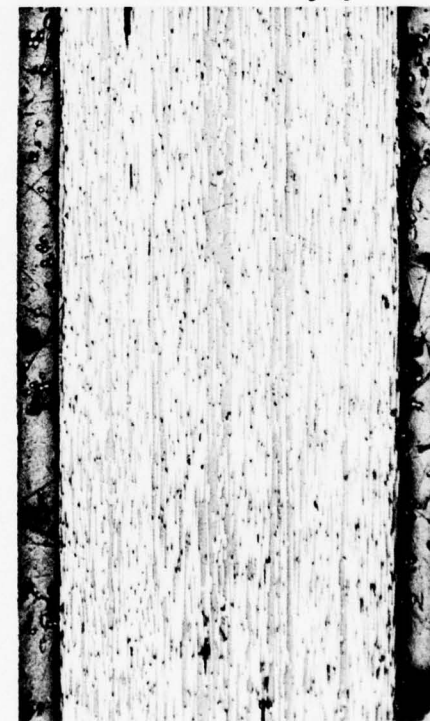
Figure 41: Steel Clad Laminate
After Thermal Shock (50X)
